ERP HOME INSPECTIONS MD

123 Main Street
Baltimore, MD 21202

JANUARY 19, 2023

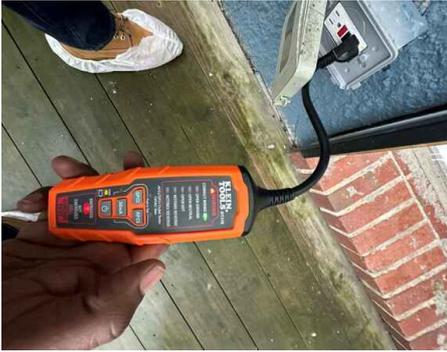
Exterior, Rear

I inspected ground-fault circuit interrupter (GFCI) receptacles. All GFCI's throughout the home, tested during my inspection, were functional.

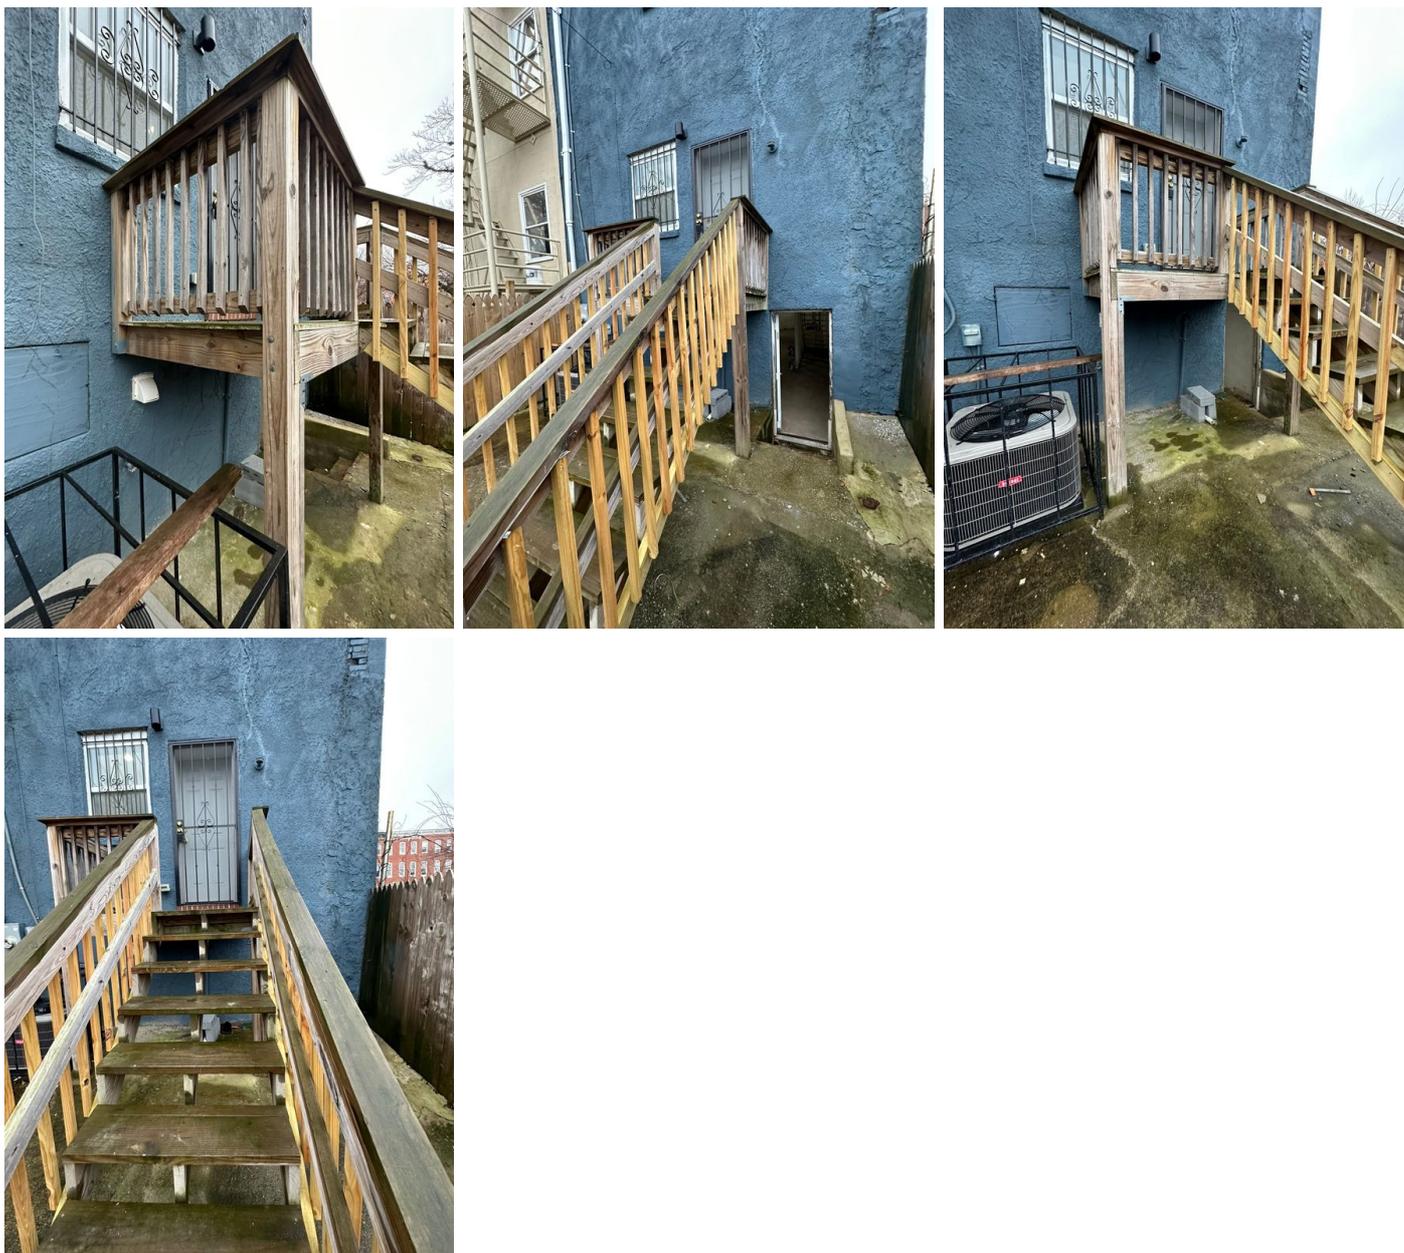
I inspected the decks at the house that were within the scope of the home inspection. I observed indications of a defect at the ledger board of the deck. **See recommendations.**

I inspected the railings, guards and handrails that were within the scope of the home inspection. Lag bolt broken on ledger board (see recommendations).

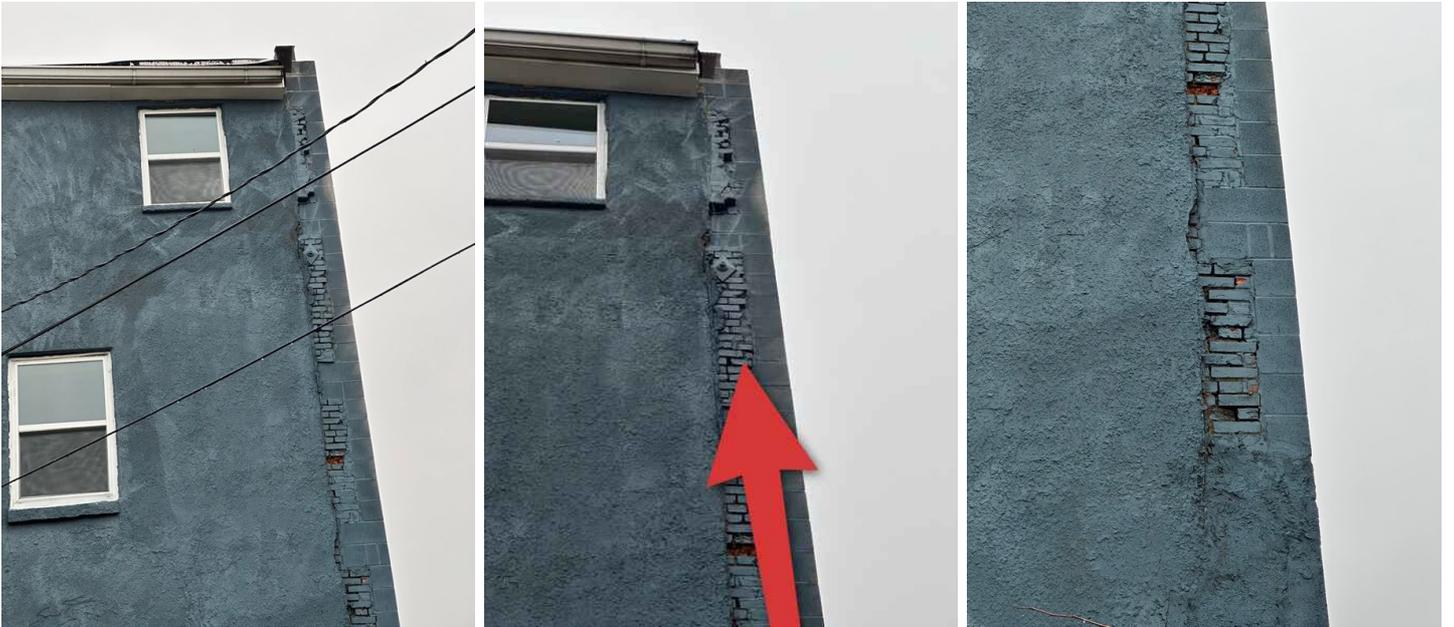
CRACKING - MAJOR AT MASONRY EXTERIOR

I observed indications of structural cracking at the time of my inspection of the exterior. Cracking was observed at one or more areas. Further evaluation by an engineer or licensed general contractor is recommended.

Contact a qualified masonry professional.

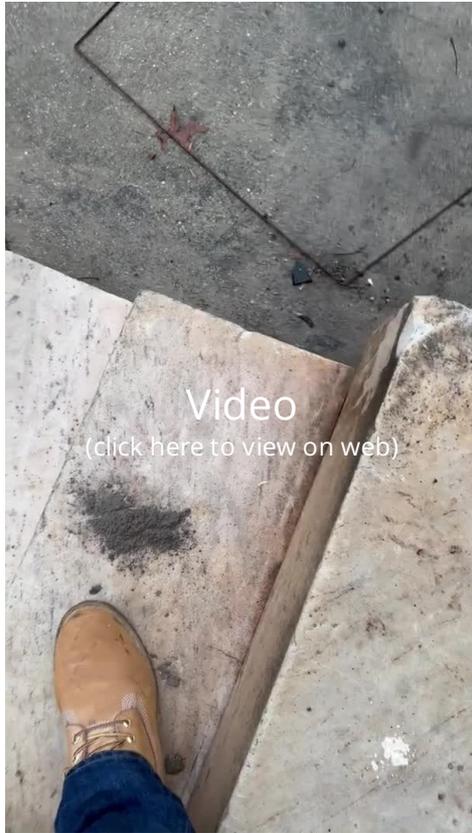
2.4.1 Walkways & Driveways

MAJOR CRACKING AT DRIVEWAY

Recommend contractor to evaluate and repair if needed.

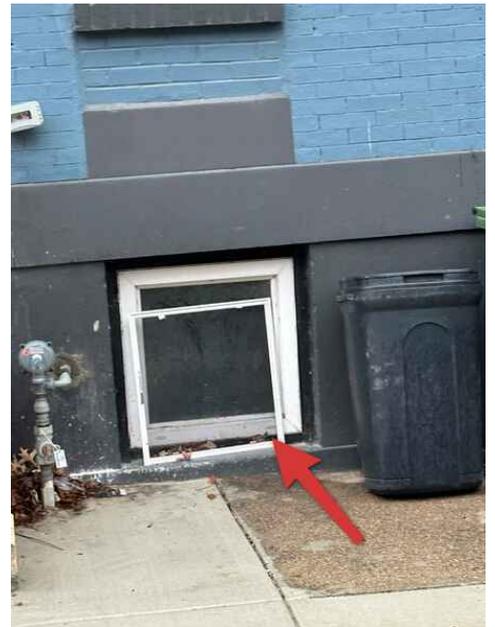
2.8.1 Windows

MISSING WINDOW SCREEN

I observed a detached window screen. Correction is recommended.

Contact a handyman or DIY project

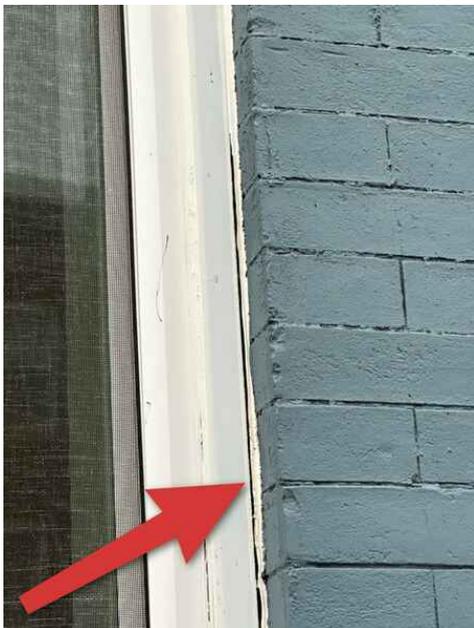
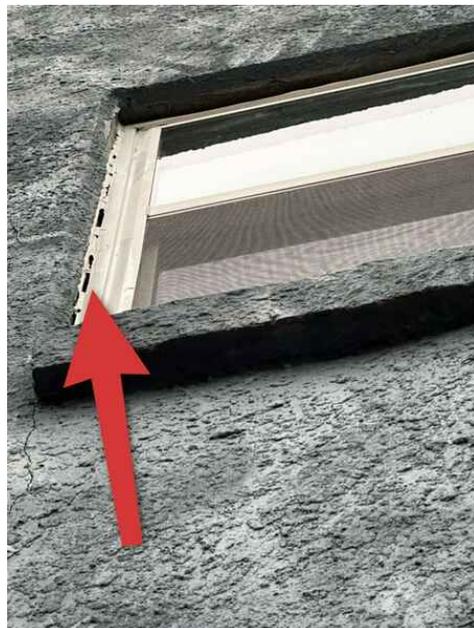
2.8.2 Windows

CAULK MISSING AROUND EXTERIOR WINDOWS

Contact a handyman or DIY project

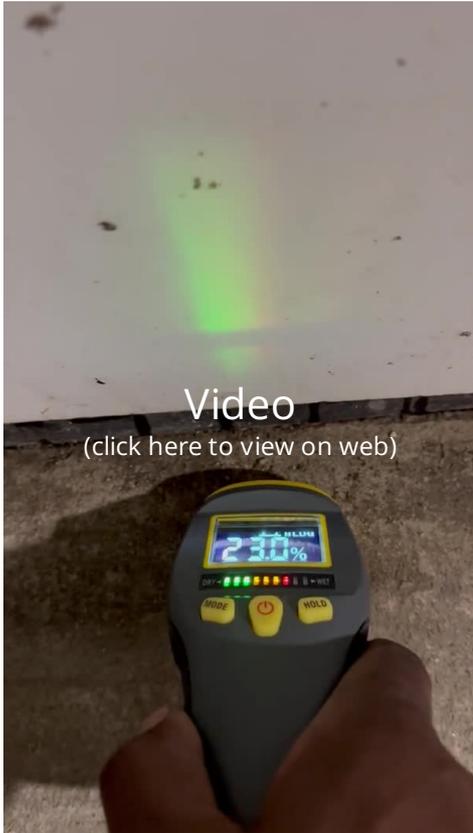
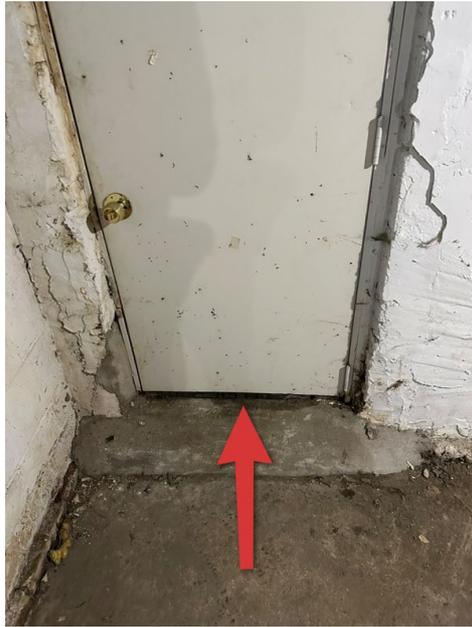
2.9.1 Exterior Doors

REPLACE EXTERIOR DOOR WEATHER STRIPPING

Weather stripping missing on rear basement door. Recommend adding weather stripping and repairing the paint on the foundation around the door.

Contact a handyman or DIY project

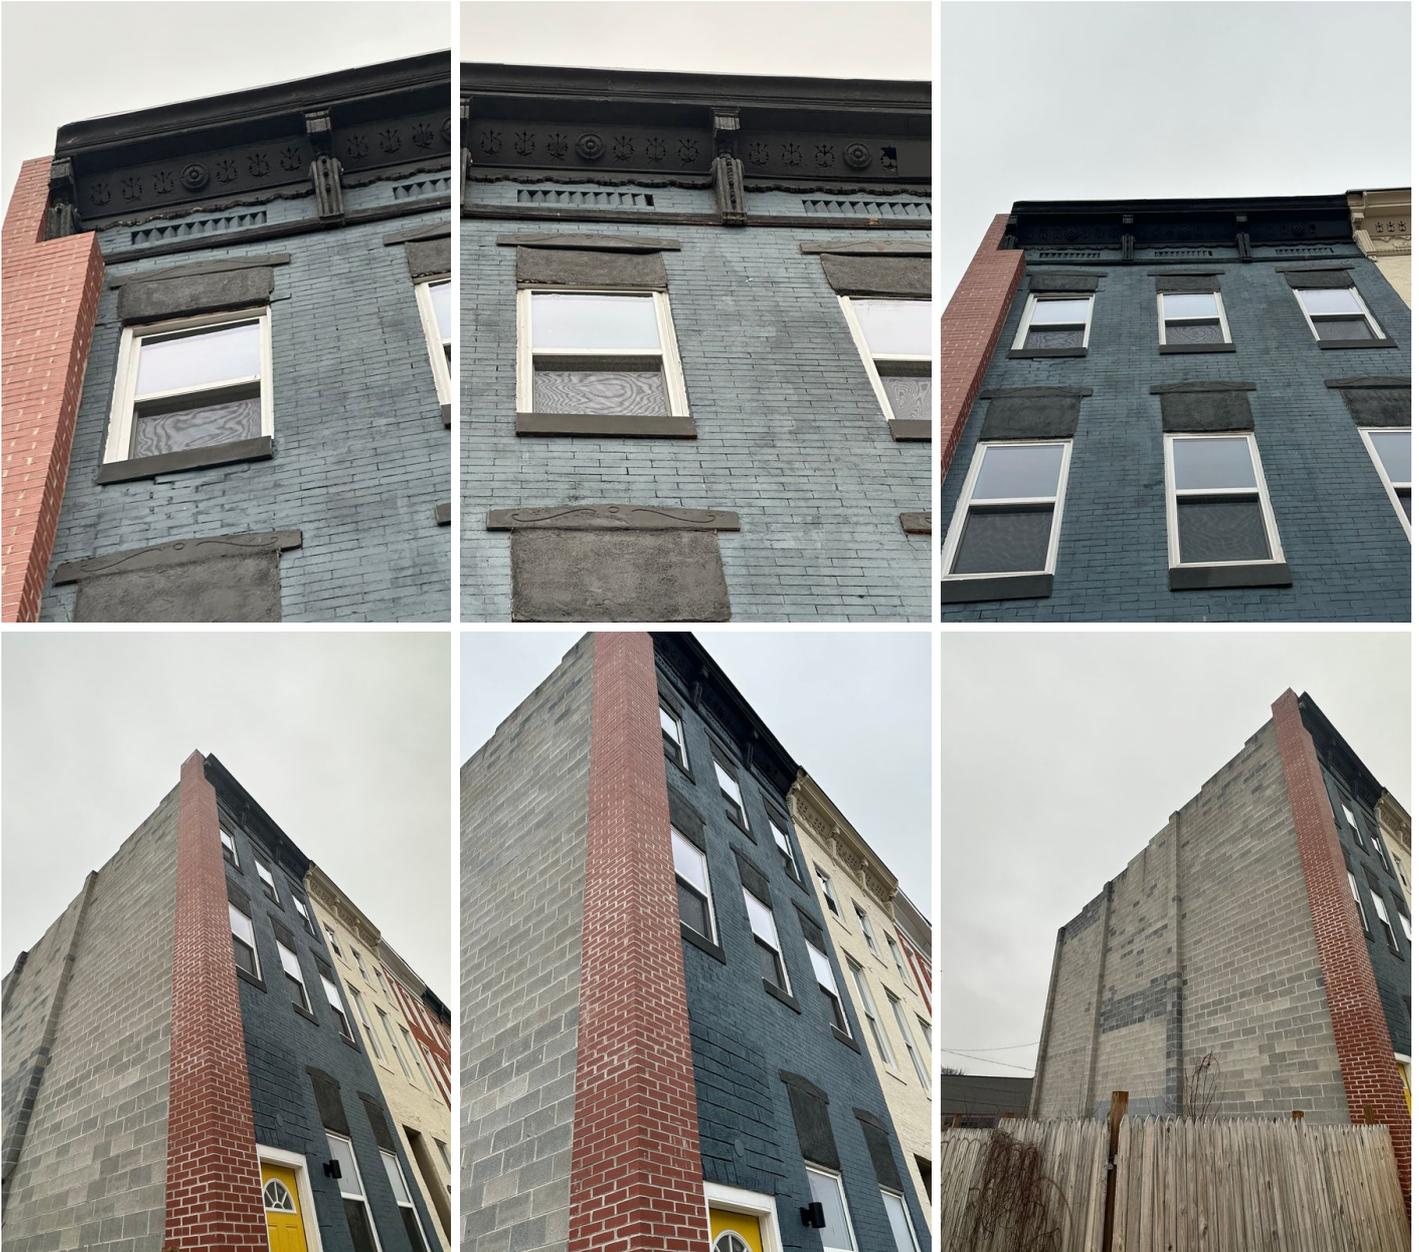
Roof Covering: Roof Was Inspected

This is a visual-only inspection of the roof-covering materials. It does not include an inspection of the entire roof. There are components of the roof that are not visible or accessible at all, including the underlayment, decking, fastening, flashing, age, shingle quality, manufacturer installation recommendations, etc. Recommend Roof Certification.

Recommend roof certification.

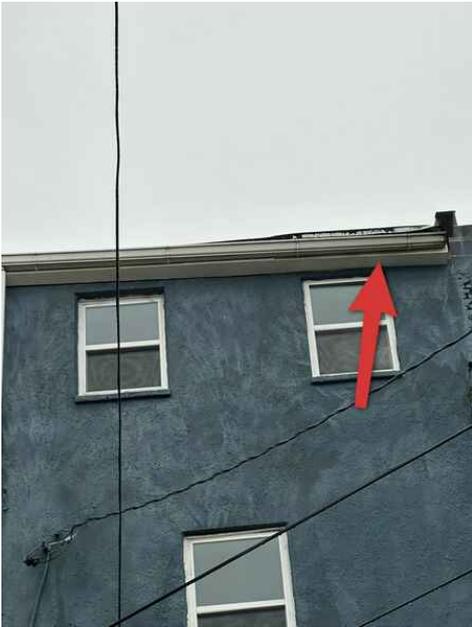
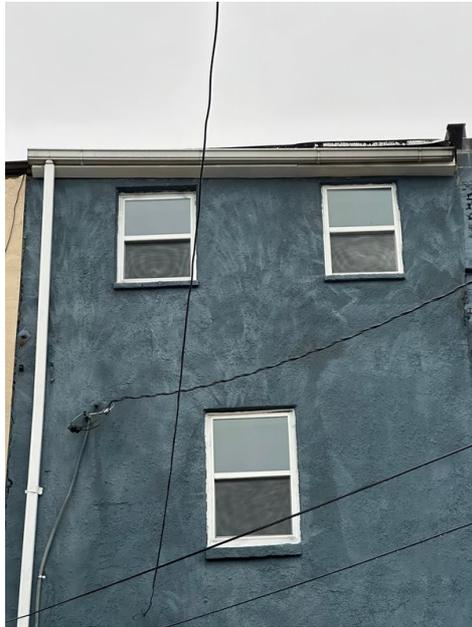
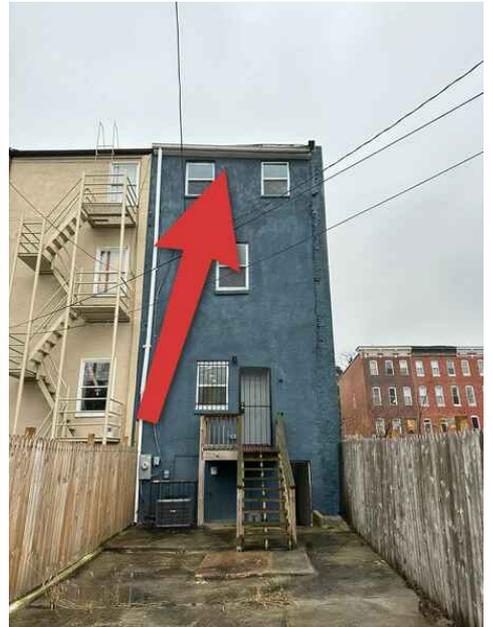
GUTTER IMPROPERLY SLOPED

I observed that the gutter showed indications of improper slope. Gutters are supposed to be sloped down toward the downspout of the gutter. That would be proper drainage of the gutter. This is a defect that should be corrected by a professional contractor.

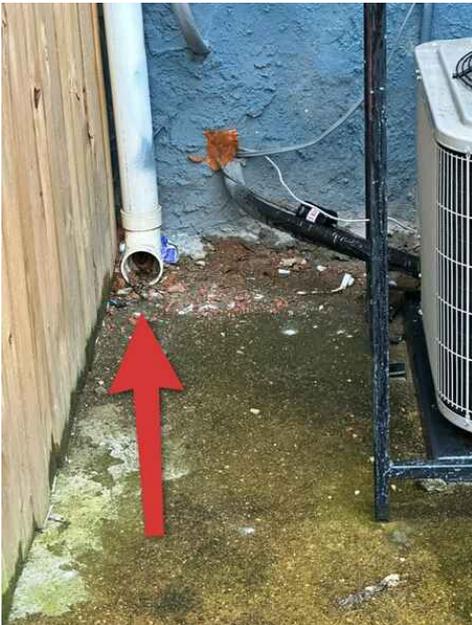
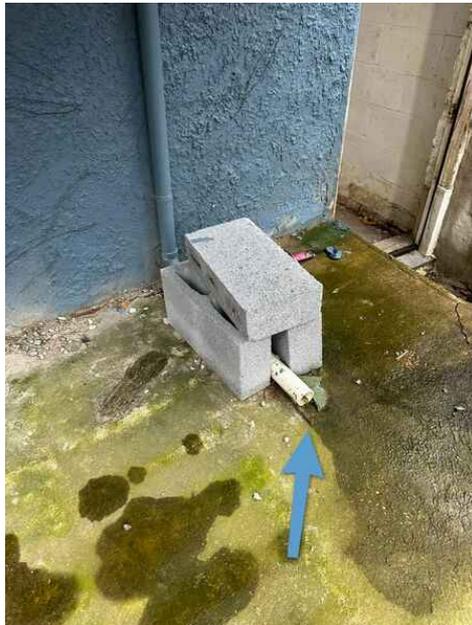
3.2.2 Gutters & Downspouts

DOWNSPOUTS DRAIN NEAR HOUSE

One or more downspouts drain too close to the home's foundation. This can result in excessive moisture in the soil at the foundation, which can lead to foundation/structural movement. Recommend adjust downspout extensions to drain at least 6 feet from the foundation. A handy homeowner should be able to do this project.

Contact a handyman or DIY project

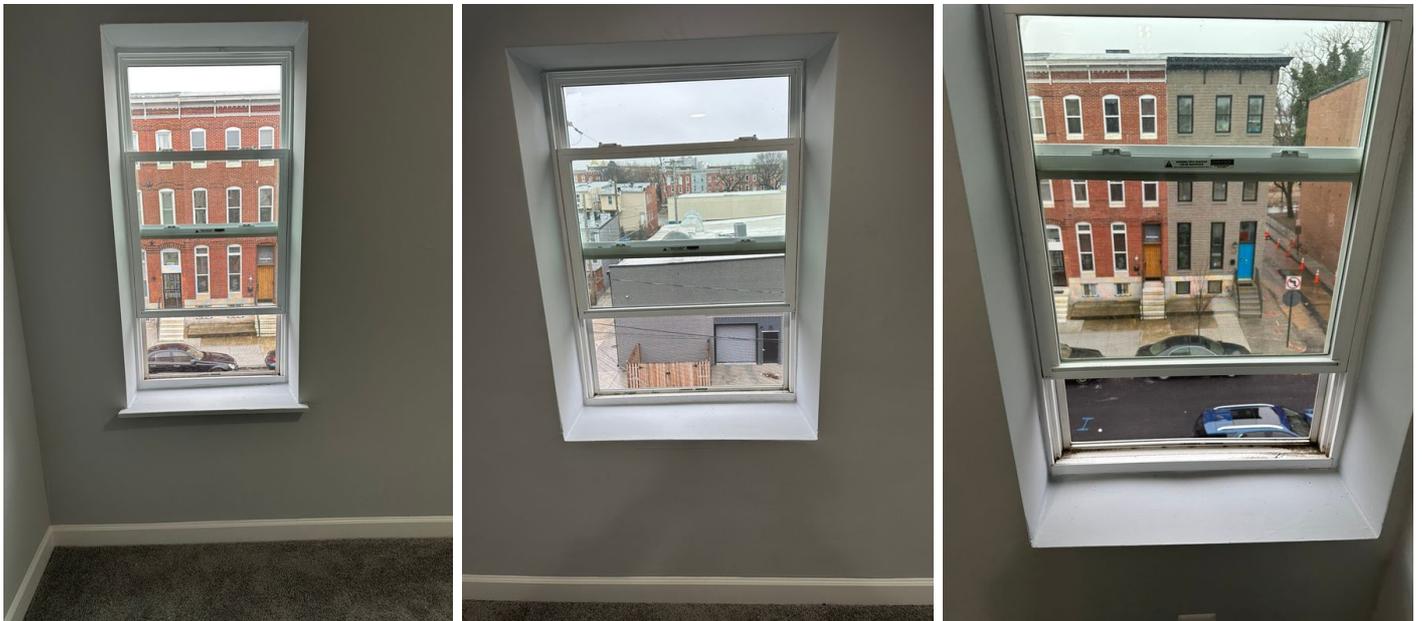
Upper Level Bedrooms

I inspected a representative number of windows. All inspected were operable at the time of the inspection. I did not operate window locks and operation features, which is beyond the scope of a home inspection.

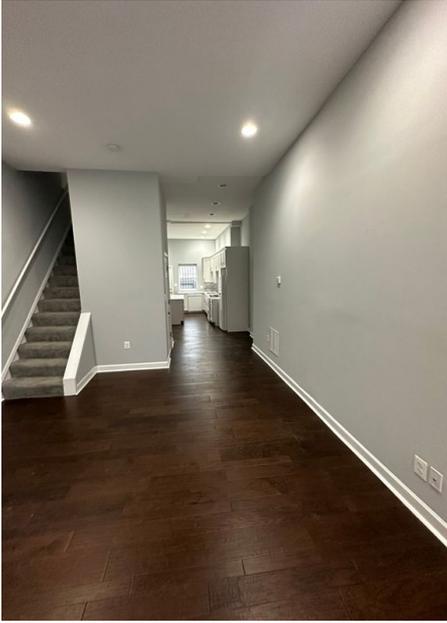
I inspected a representative number of switches, lighting fixtures and receptacles on every level of the property. All inspected switches, lighting fixtures and receptacles were operable at the time of the inspection.

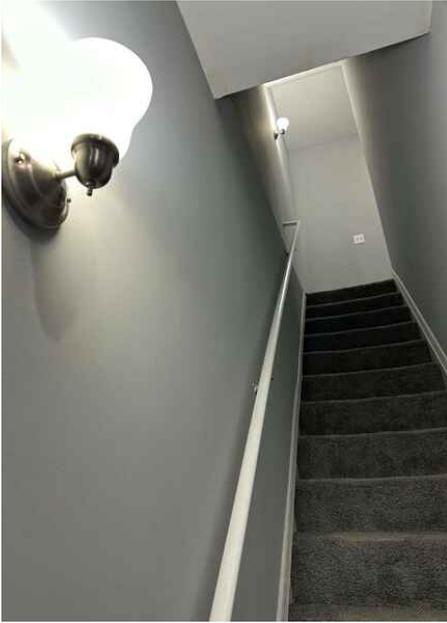
I inspected the stairs, steps, stoops, and stairways that were within the scope of my home inspection. They were acceptable. All treads should be level and secure. Riser heights and tread depths should be as uniform as possible. As a guide, stairs must have a maximum riser of 7-3/4 inches and a minimum tread of 10 inches.

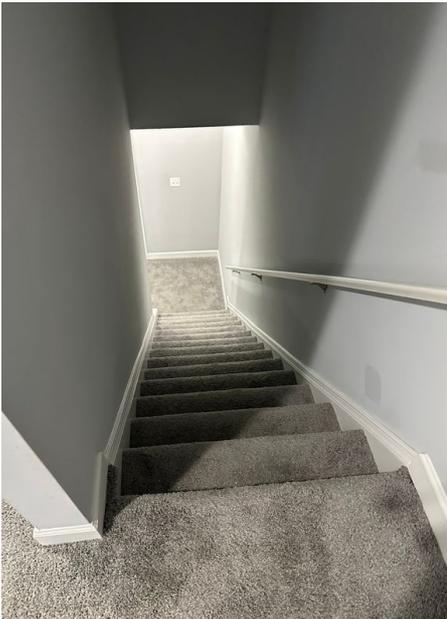
I inspected a representative number railings, guards and handrails that were within the scope of the home inspection. They were acceptable.

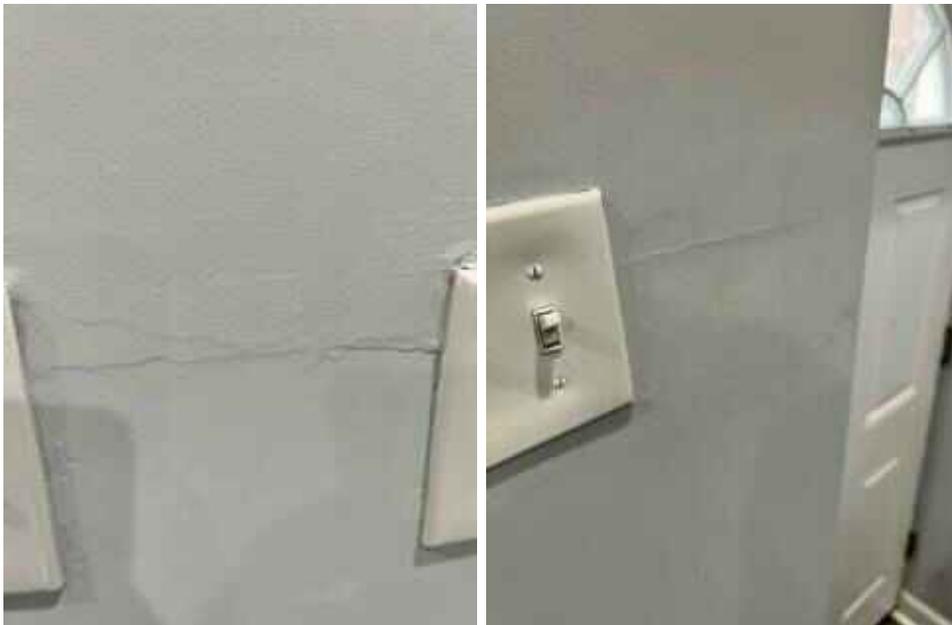
MINOR CORNER CRACKS

Minor cracks at the corners of doors and windows in walls. Appeared to be the result of long-term settling. Some settling is not unusual in a home of this age.

Contact a qualified drywall contractor.

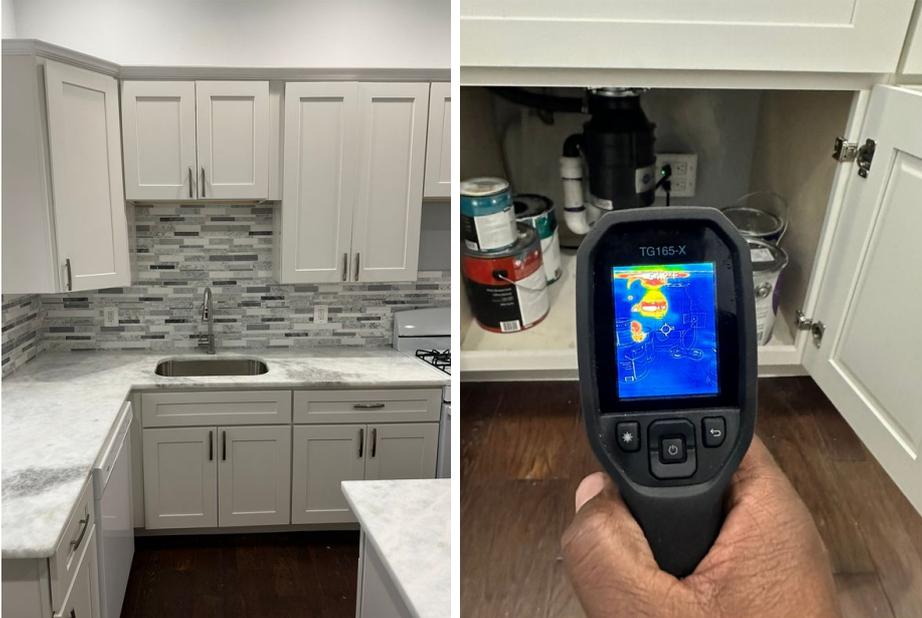
I ran water at the kitchen sink. Kitchen sink operable at the time of the inspection.

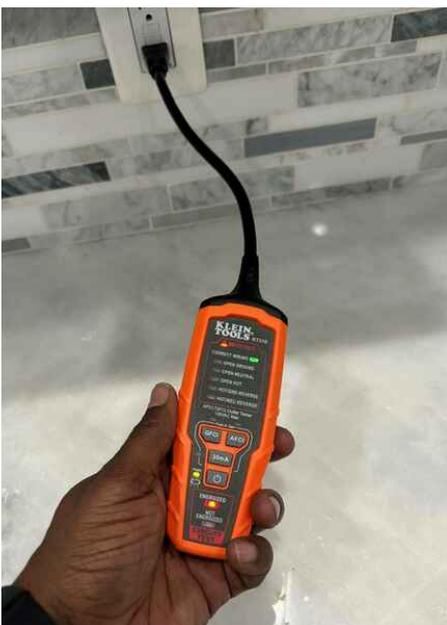
Kitchen

I observed ground fault circuit interrupter (GFCI) protection in the kitchen. All GFCI's were operable at the time of the inspection.

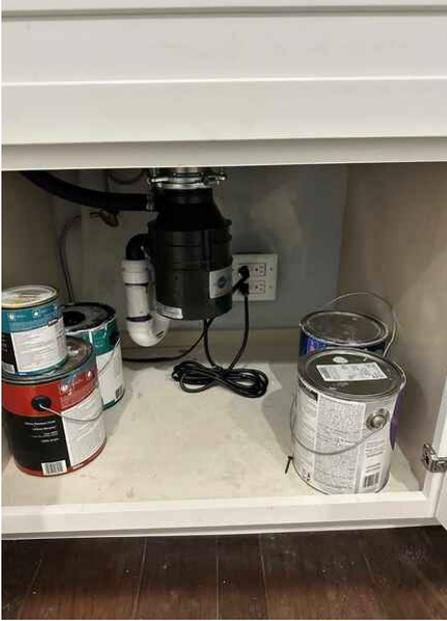
I turned on the garbage disposal. Garbage disposal operable at the time of the inspection.

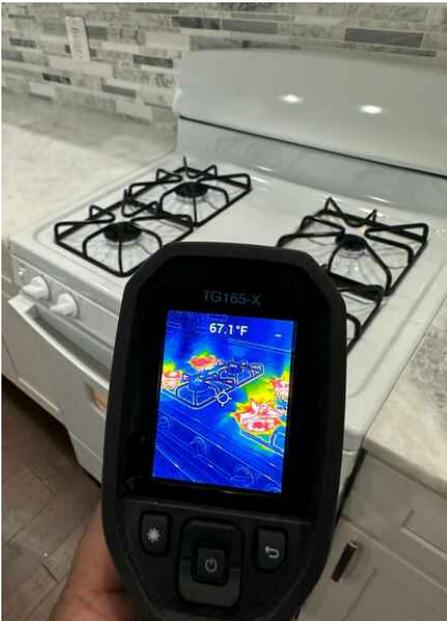
Kitchen

I turned on the kitchen's stove and oven. Range operable at the time of the inspection.

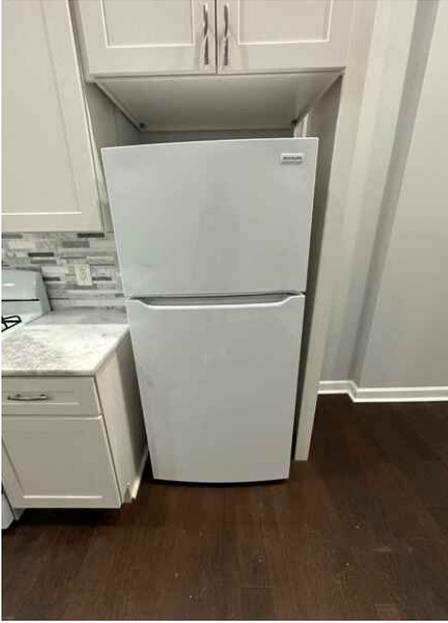
Kitchen

I checked to see if it was functional. Refrigerator was operable at the time of the inspection.

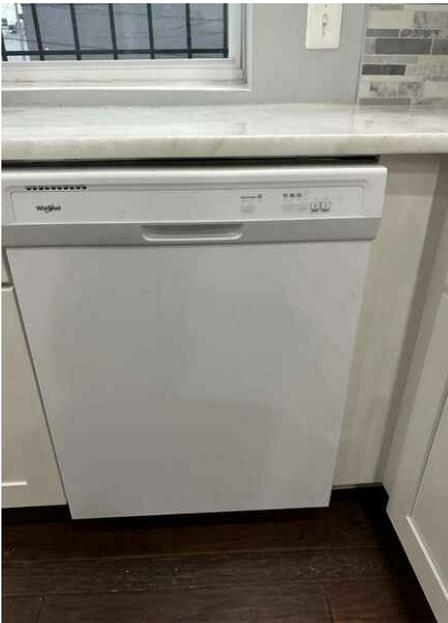
I inspected the dishwasher by turning it on and letting it run a short cycle. Dishwasher was operable at the time of the inspection.

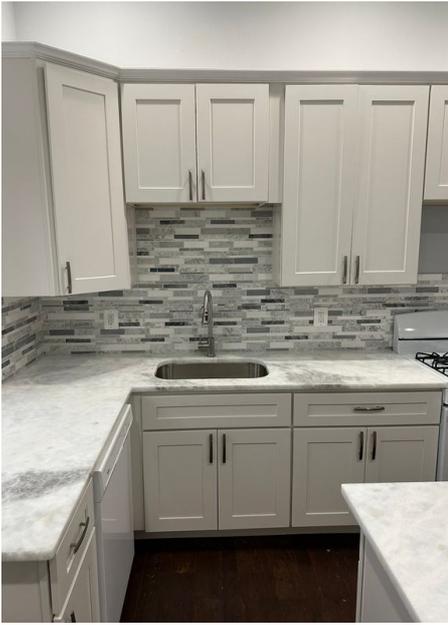
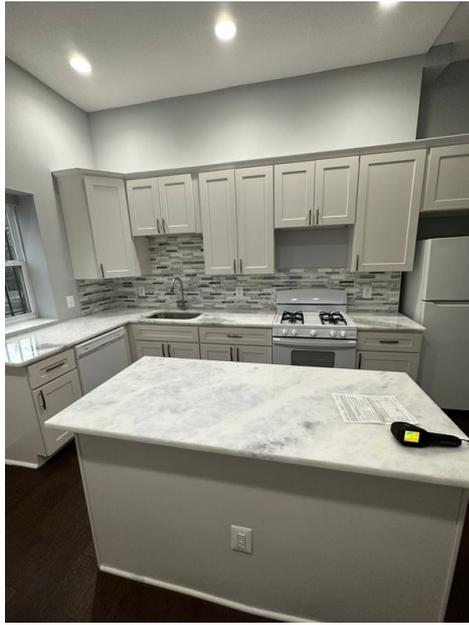
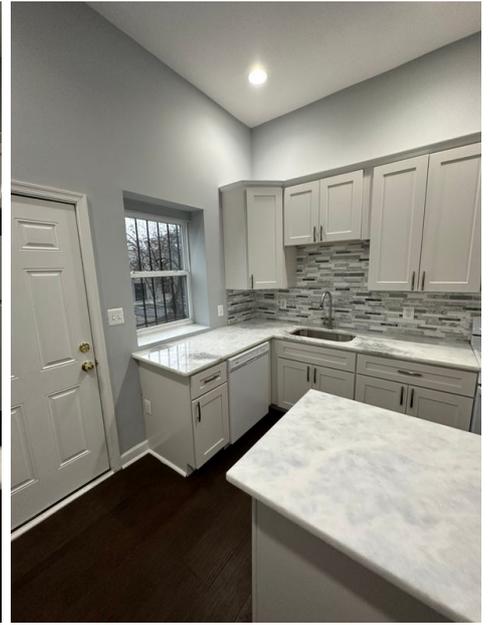
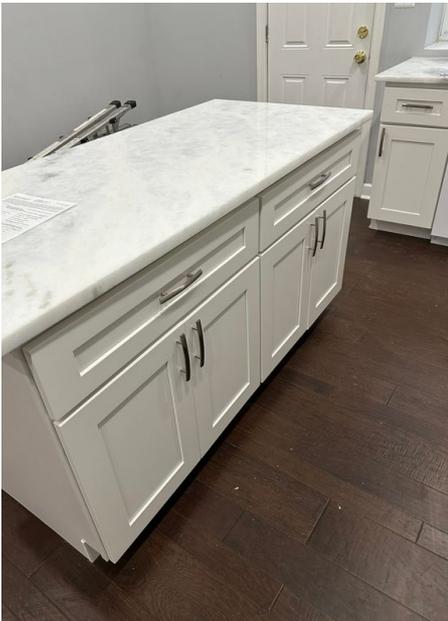
I inspected a representative number of cabinets and countertop surfaces. All cabinets were functional at the time of the inspection.

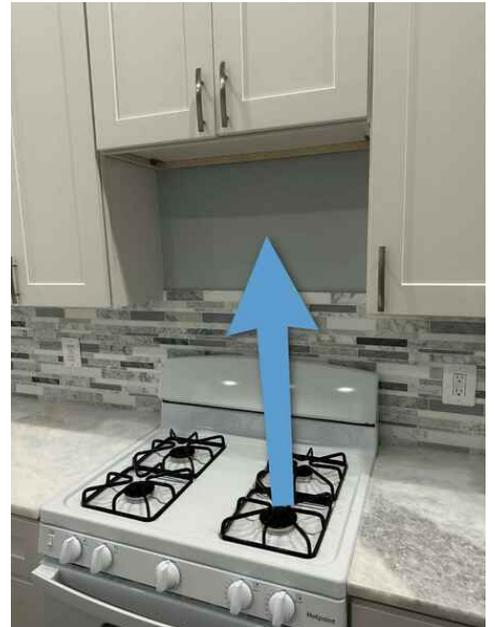
5.7.1 Exhaust Fan

EXHAUST FAN MISSING

I observed that there was no exhaust system. Recommend exhaust fan be installed .

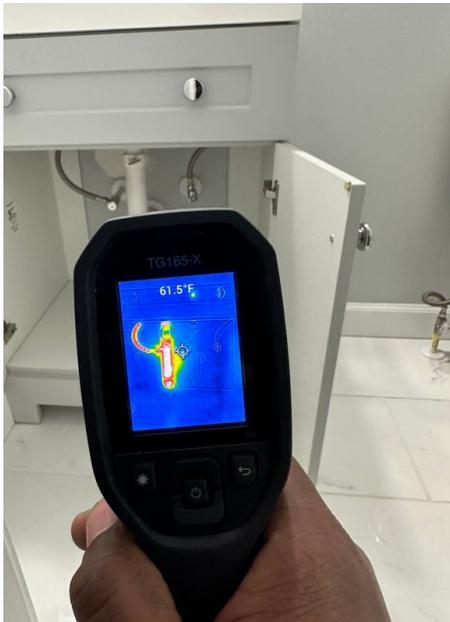
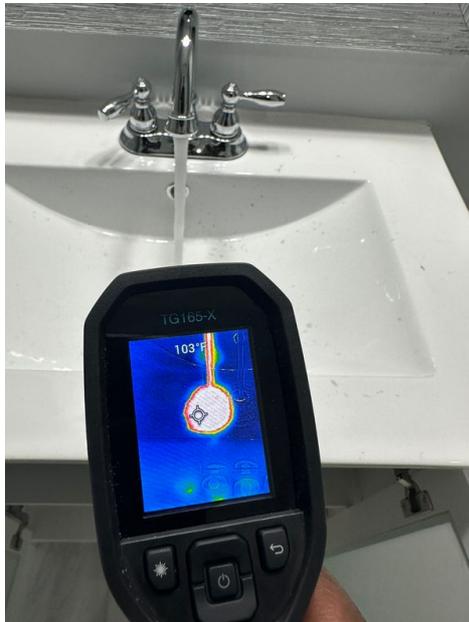
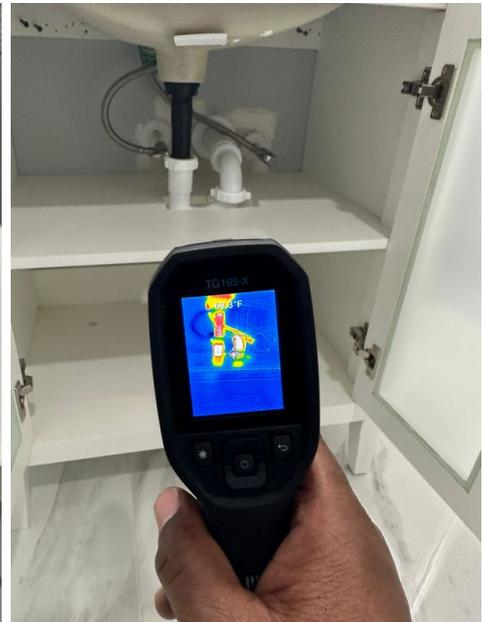
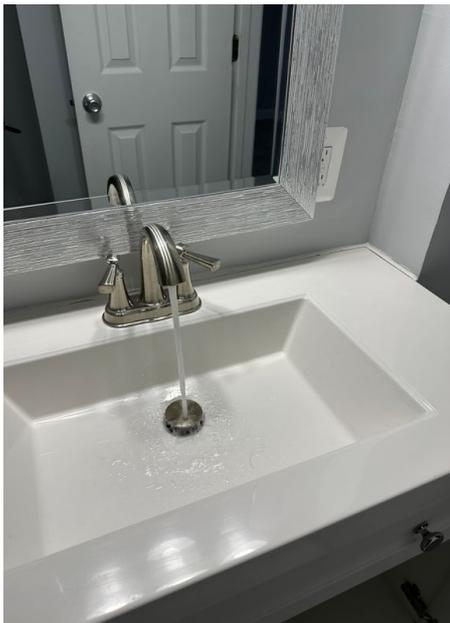
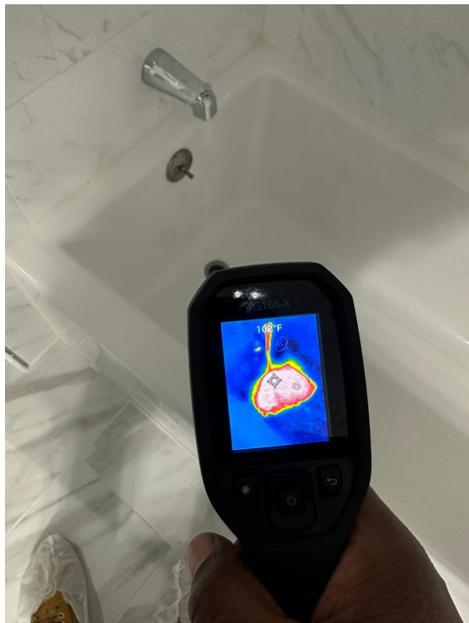
All sinks

I ran water at all bathroom sinks, bathtubs, and showers. I inspected for deficiencies in the water supply by viewing the functional flow in two fixtures operated simultaneously. All sinks, tubs and showers were operable at the time of the inspection.

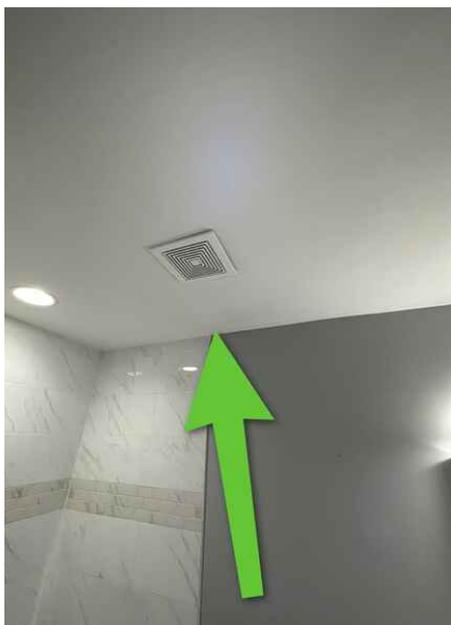
All locations

I inspected the exhaust fans of the bathroom(s). All mechanical exhaust fans should terminate outside. All exhaust fans were operable at the time of the inspection.

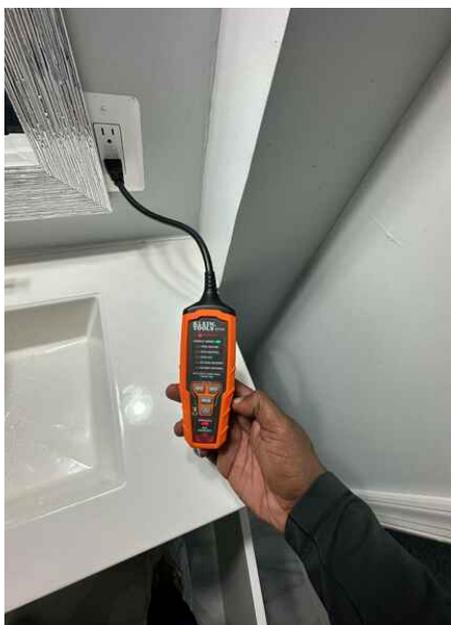
Random locations

All receptacles in the bathroom must be GFCI protected.

All receptacles were operable at the time of the inspection.

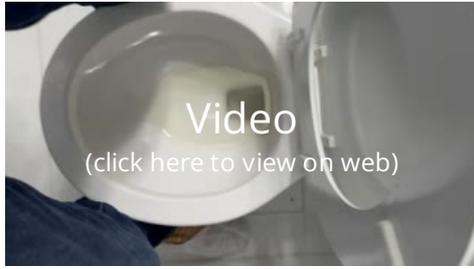
LOOSE AND/OR ROCKING TOILET

Contact a handyman or DIY project

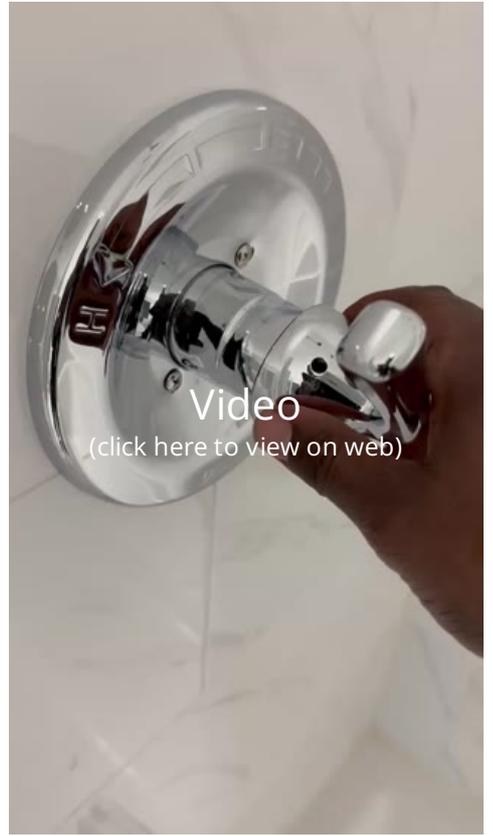
I observed that the fixture handle is loose.

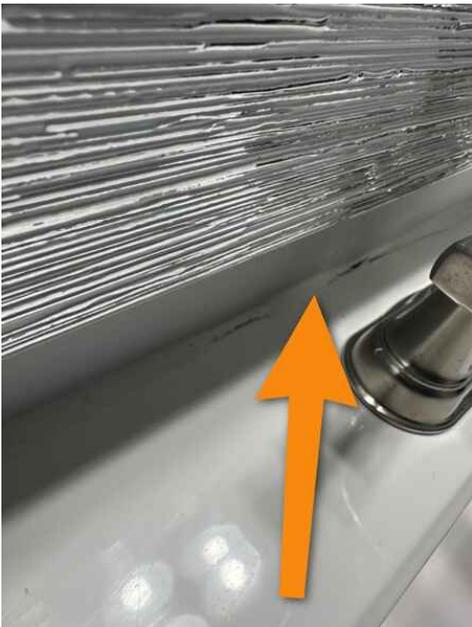
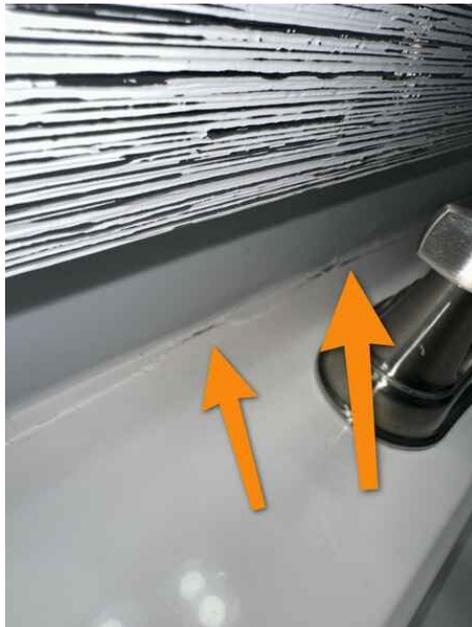
MISSING CAULK AROUND BATHROOM SINK

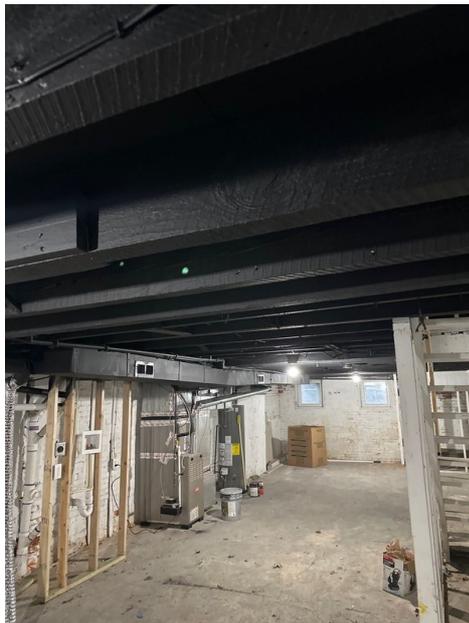
Structural components were inspected . [See recommendations.](#)

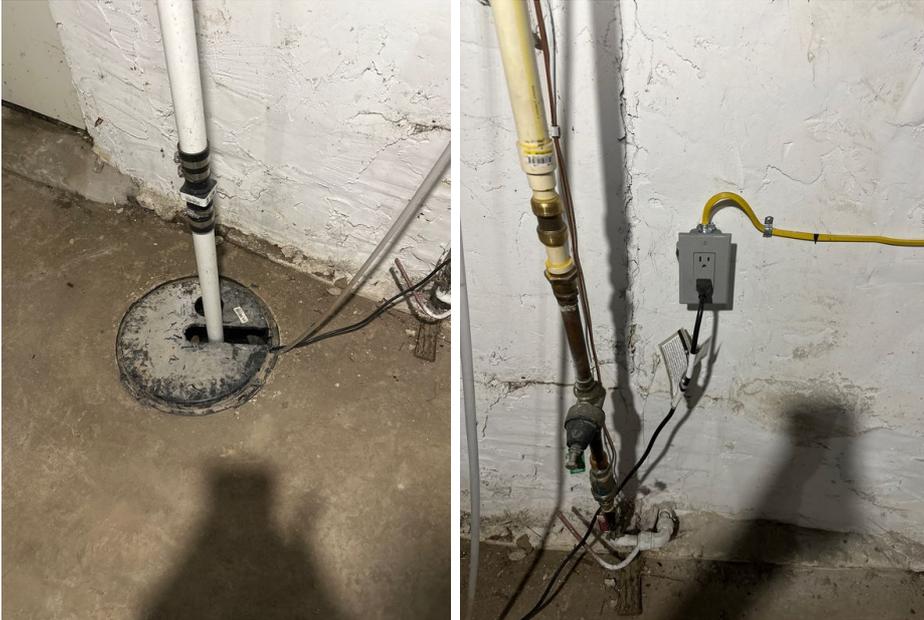
I observed a sump pump was installed in the house.

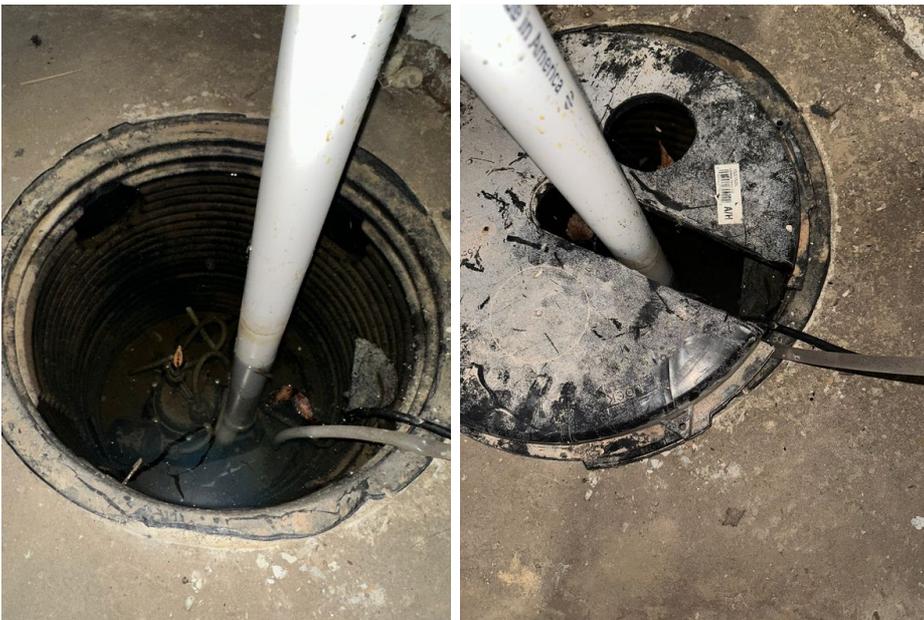
Sump Pump: Water in Sump Pump

I observed standing water in the sump pump bucket. This may indicate that the sump pump is critical and necessary to keep the house basement or foundation from having water intrusion problems developing.

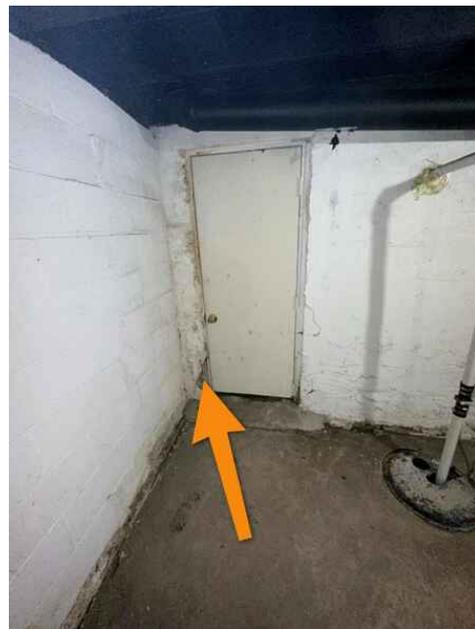
WALL DETERIORATION

Wall deterioration.

Correction and further evaluation is recommended.

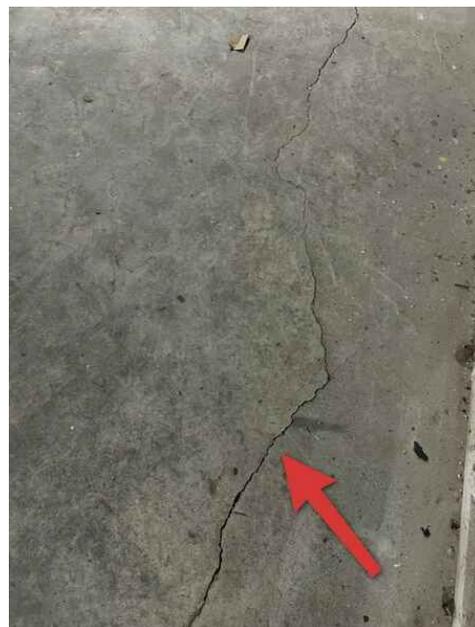
7.1.2 Basement

BASEMENT FLOOR CRACK IN FLOOR

I observed a crack in the basement floor. Further evaluation is recommended.

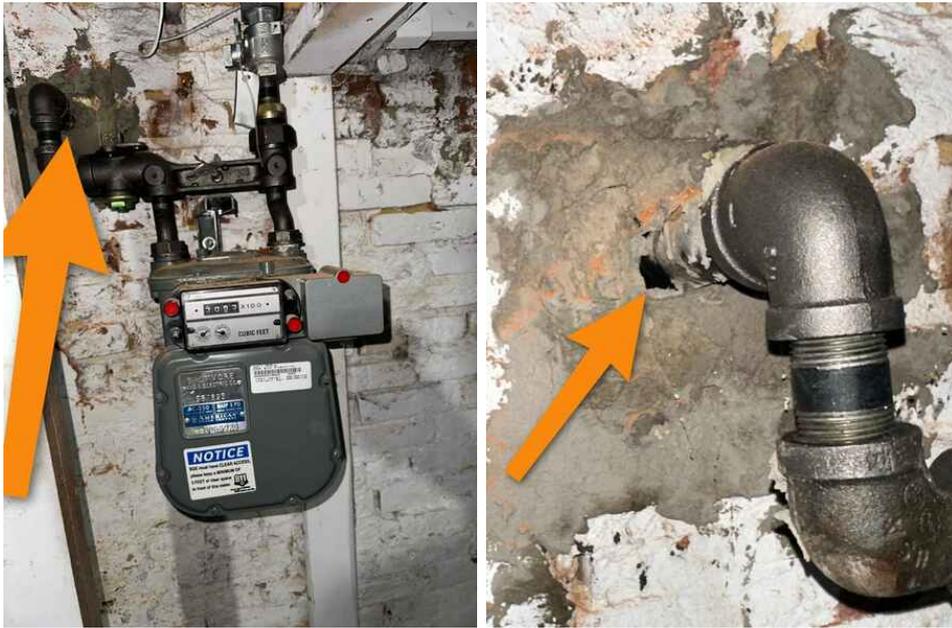
7.1.3 Basement

WALL CRACK NEEDS TO BE REPAIRED

Wall crack needs to be repaired.

Contact a handyman or DIY project

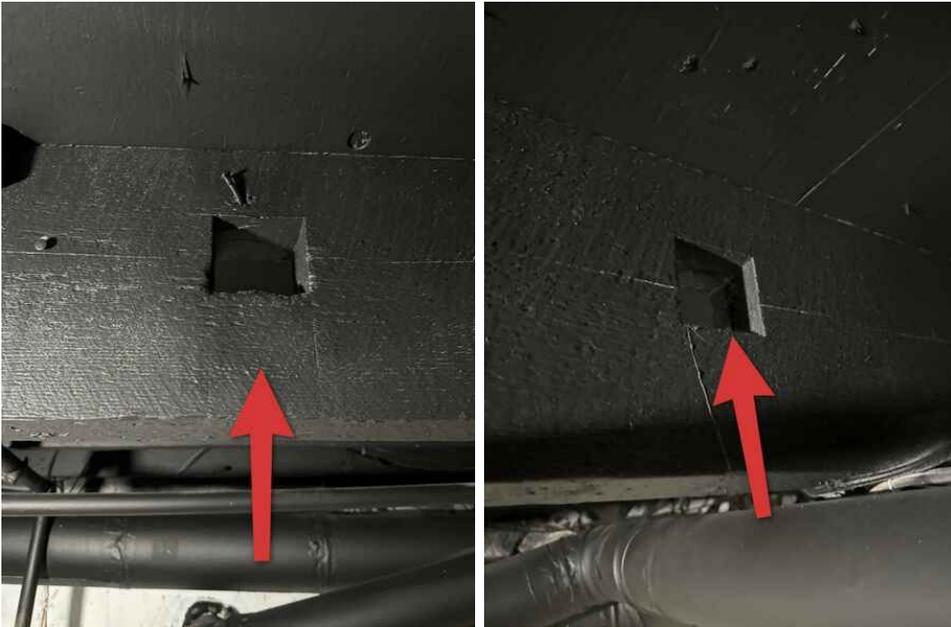
7.1.4 Basement

IMPROPER NOTCH, HOLE, OR CUT

I observed indications of cutting, notching and boring of framing members that may, in my opinion, present a structural or safety concern.

There are structural concerns because of this condition. Major defect.

Correction and further evaluation is recommended.

Contact a qualified general contractor.

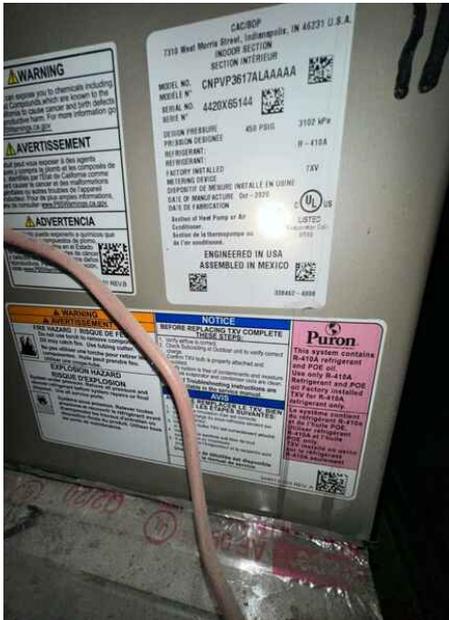
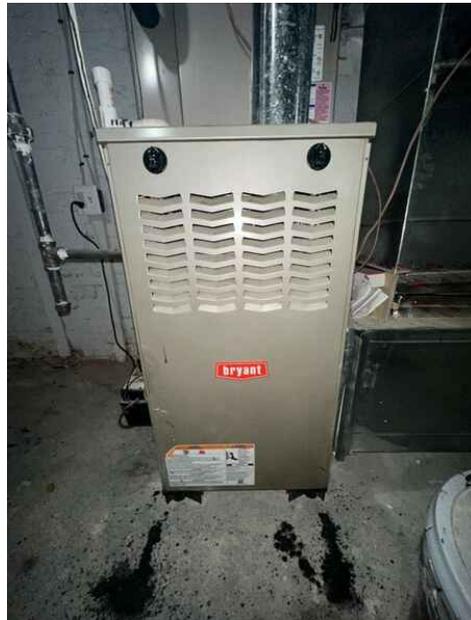
Brand: Bryant

Manufacturer Date: Oct 2020

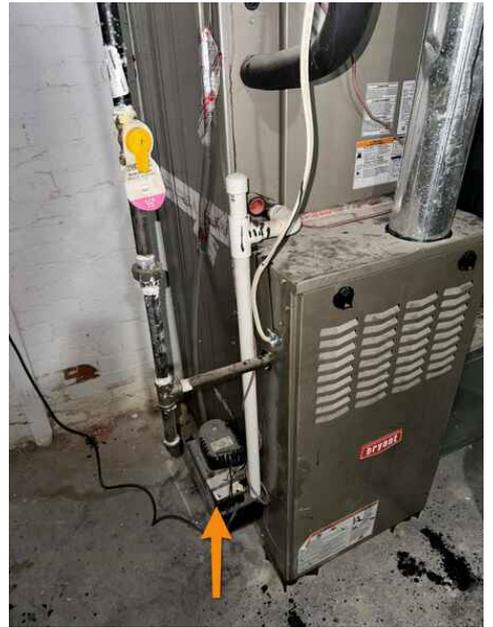
DID NOT OPERATE

The condensate pump did not operate during my home inspection. Forcing the pump to discharge is beyond the scope of my home inspection. Ask the seller for more information about the condensate pump and its past performance.

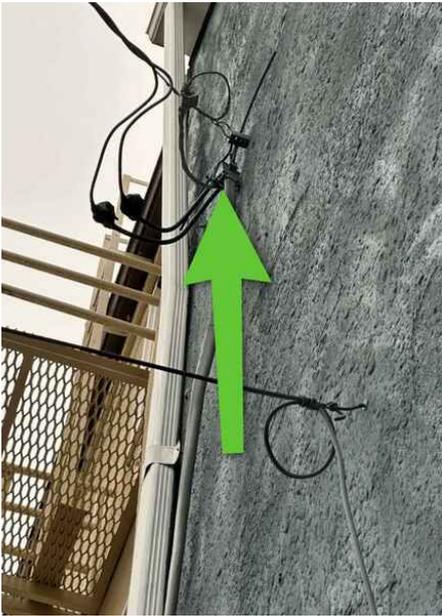
I inspected the electrical service-entrance conductors.
