ERP HOME INSPECTIONS MD

123 Main Street
Baltimore, MD 21202

JANUARY 19, 2023

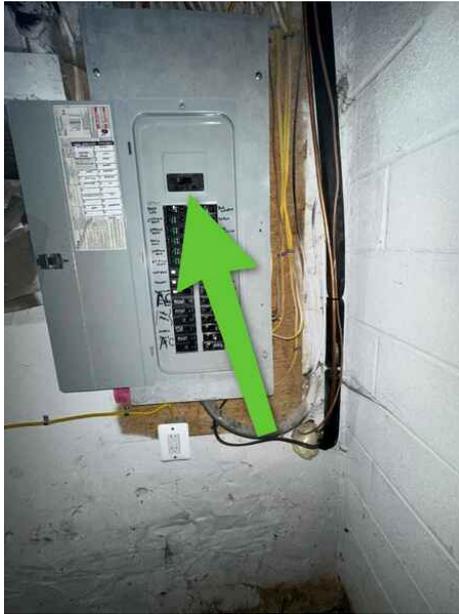
I inspected the electrical main service disconnect.

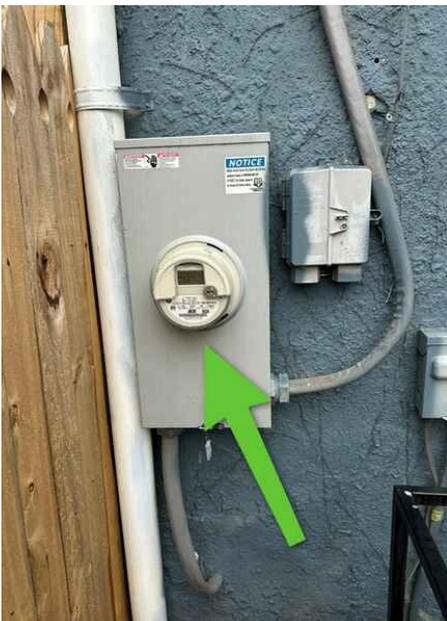
I inspected the electrical electric meter and base. Electric meter & base operable at the time of the inspection.
