HOME INSPECTION REPORT

3818 Hudson St
Baltimore, MD 21224

JUNE 3, 2023

DUANE CEPHUS, CPI®

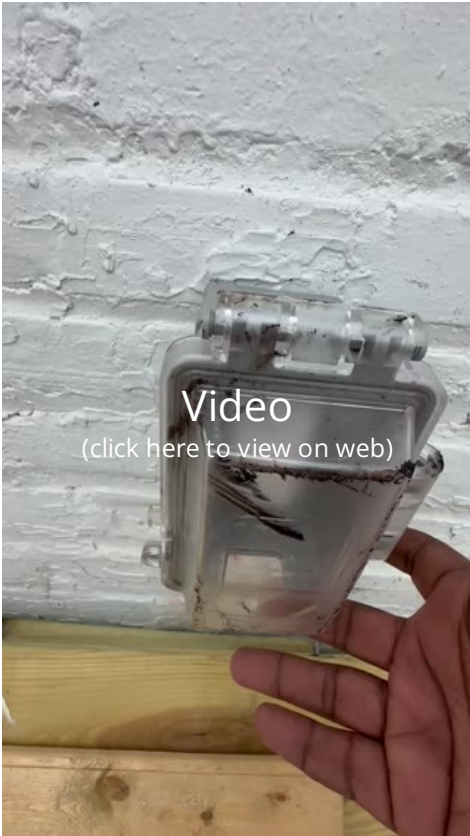
3.4.1 Electrical

OUTSIDE RECEPTACLE COVER NOT SECURED PROPERLY

REAR OUTSIDE KITCHEN DOOR

Contact a qualified handyman.

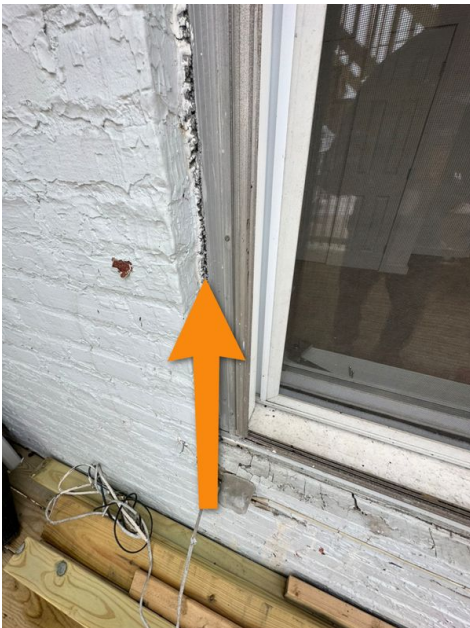
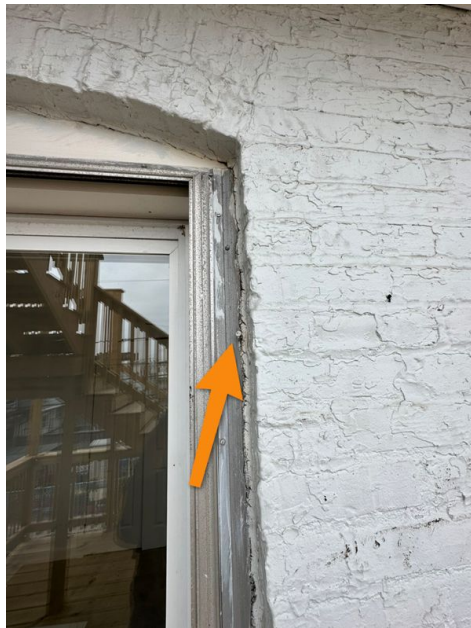
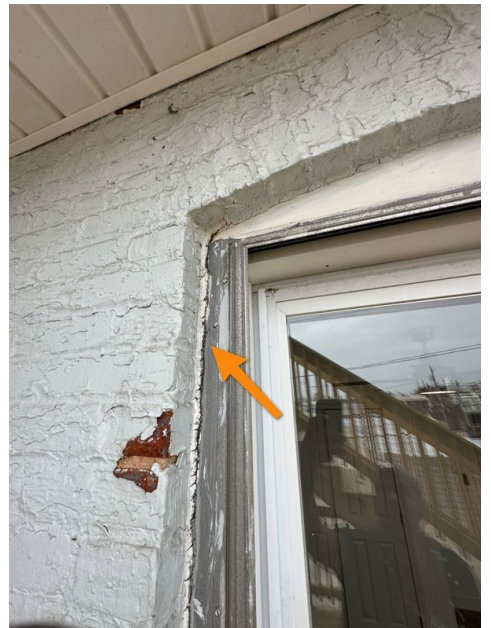
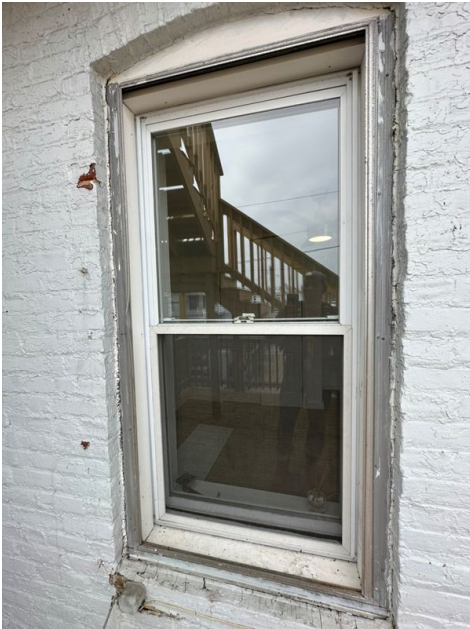
3.5.1 Windows and Door

CAULKING

Caulk was *missing / deteriorated / substandard* in some areas. For example, *around windows / around doors / at siding butt joints / at siding-trim junctions / at wall penetrations*. Recommend that a qualified person renew or install caulk as necessary. Where gaps are wider than 1/4 inch, an appropriate material other than caulk should be used. Caulking should be evaluated and applied as part of annual home maintenance

Contact a handyman or DIY project

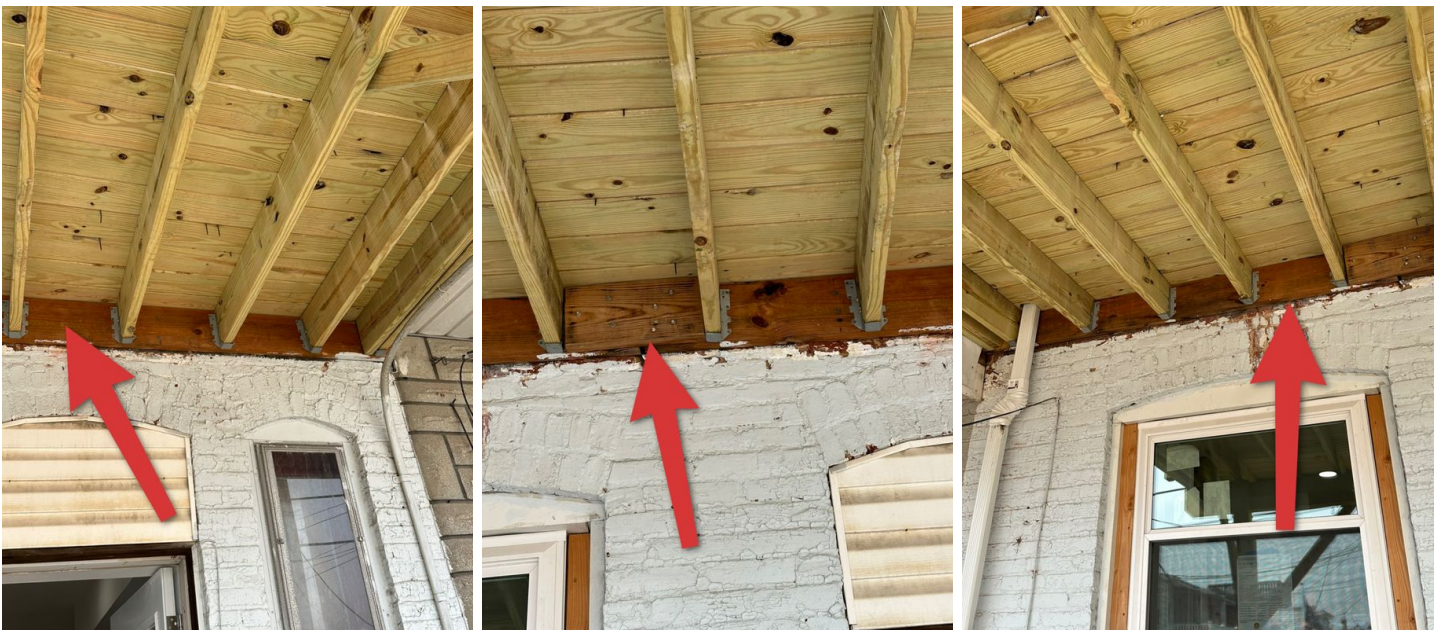
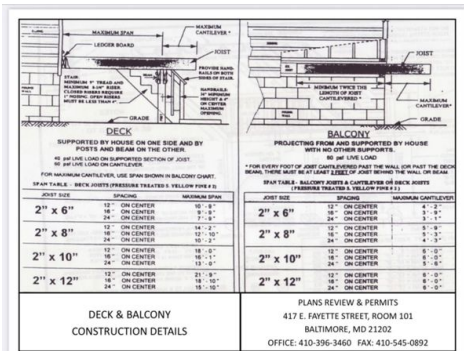
3.8.1 Porches, Patios, Decks, Balconies & Carports

LEDGER BOARD DEFECT

I observed indications of a defect at the ledger board of the deck.

The ledger board is not properly attached to the building. This can cause the deck to pull away from the building and possibly collapse. Safety defect.

Correction and further evaluation is recommended by a qualified Deck Contractor.

Contact a qualified deck contractor.

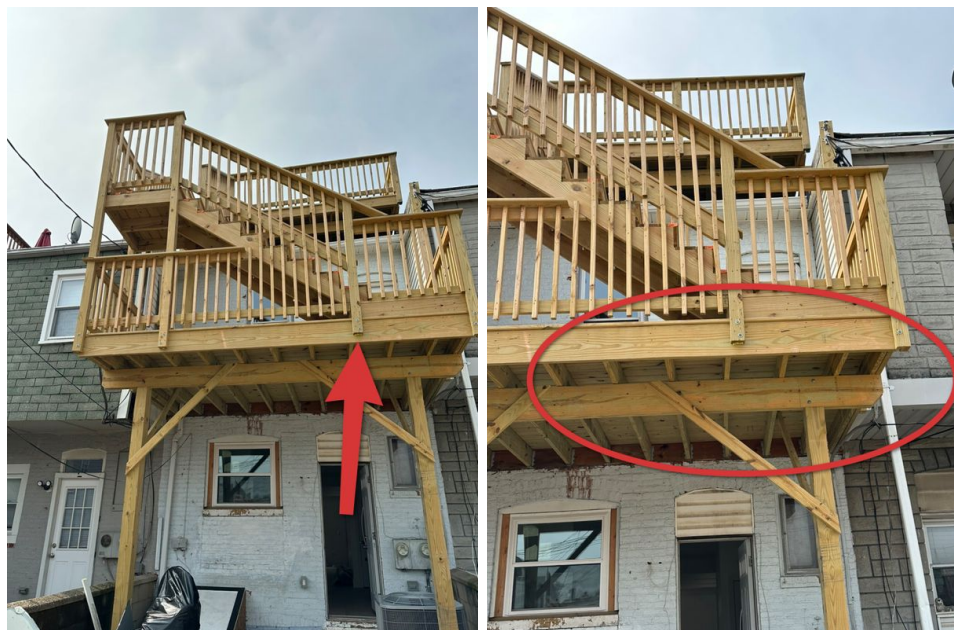
4.2.1 Steps

STEPS LOCATED ON DECK'S CANTILEVER

Check Baltimore City's Deck Code

Contact a qualified deck contractor.

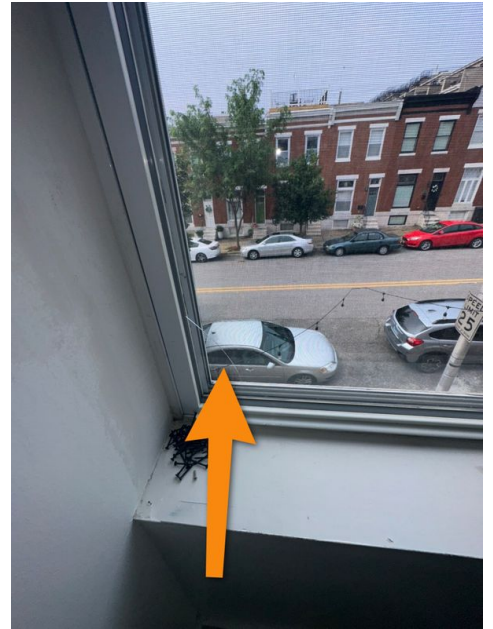
5.3.1 Windows

CRACKED WINDOW

One or more windows appears to have general damage, but are operational. Recommend repair and replace window.

Contact a qualified handyman.

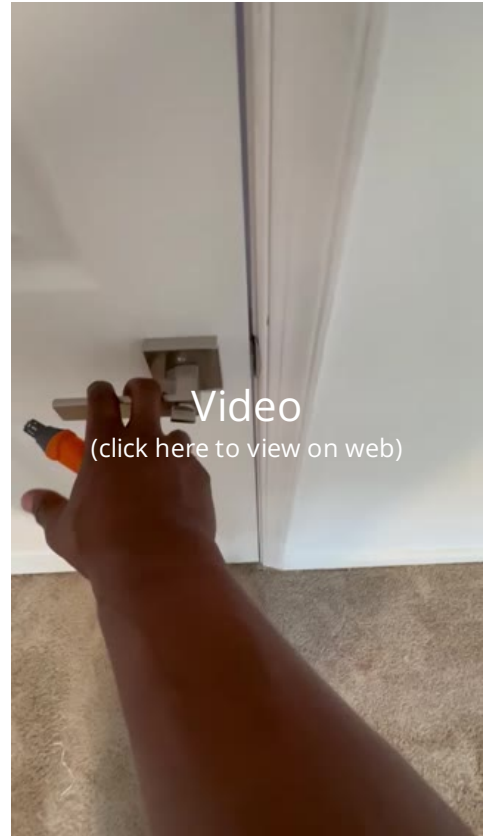
Door doesn't latch properly. Recommend handyman repair latch and/or strike plate.

Contact a qualified handyman.

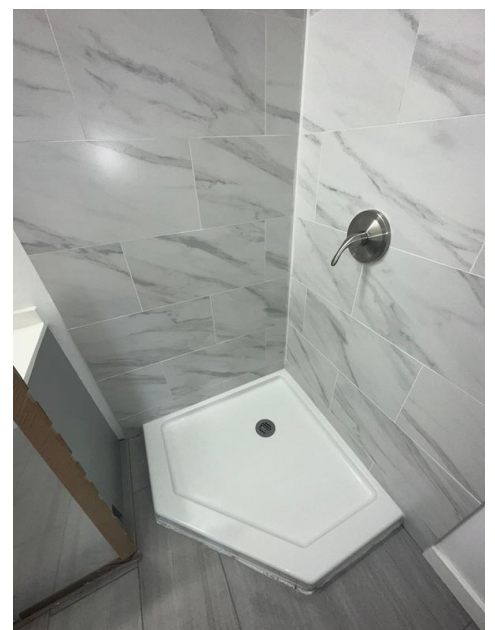
BATHTUB/SHOWER: HARDWARE MISSING

It was noticed that some hardware was missing in the bathtub or shower, which may have contributed to the low pressure issue. It is recommended that the stopper be repaired or replaced and any missing hardware be installed in order to improve the water pressure in the bathtub or shower.

Contact a qualified handyman.

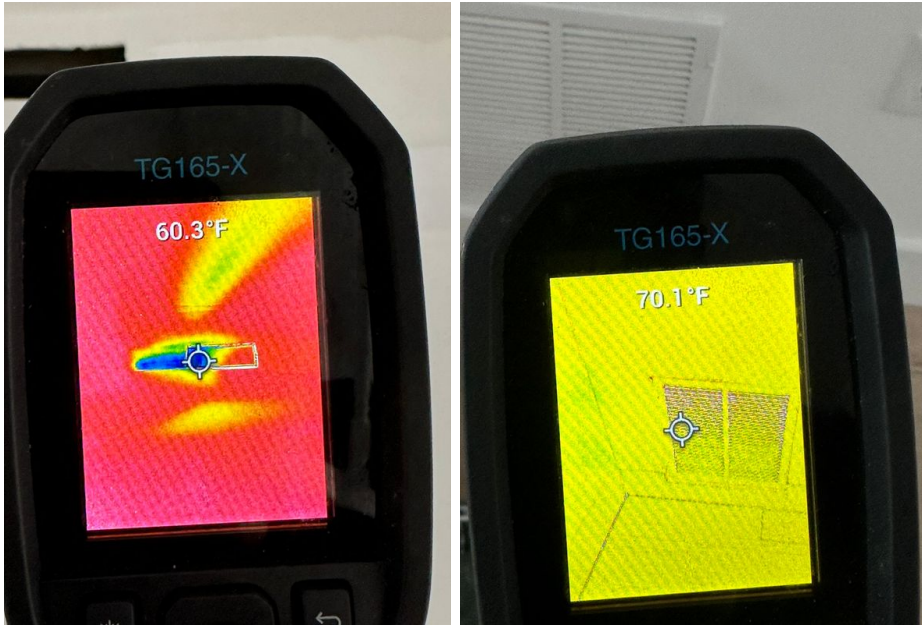
10 Degrees

This is the number of degrees the system is cooling (or heating) the house air. Normal range for this number is 10-22 degrees when operating the system during hot weather, lower when ambient temperatures are lower. The system functioned as expected when tested and appeared to be serviceable at the time of the inspection. As with all mechanical equipment, the unit may fail at any time without warning. The inspector cannot determine future failures.

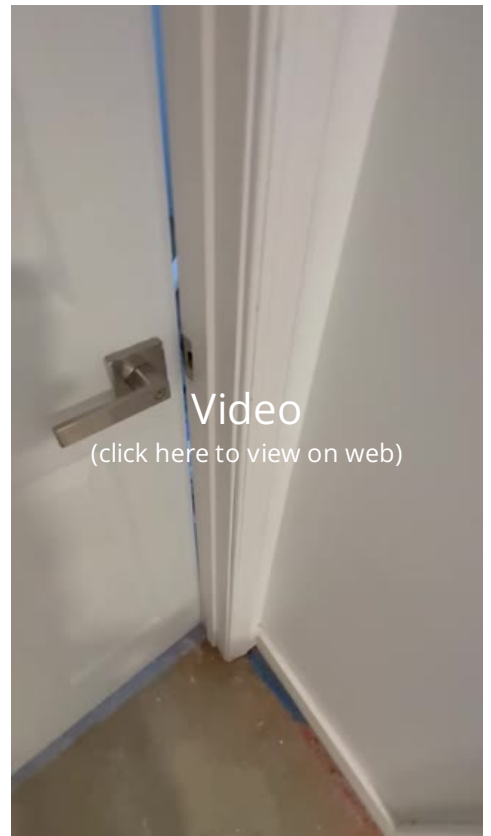
16.5.1 Windows and Door

One or more doors bind in their jamb and cannot be closed and latched, or are difficult to open and close. A qualified contractor should evaluate and repair as necessary. For example, adjusting jambs or trimming doors.

Contact a qualified handyman.

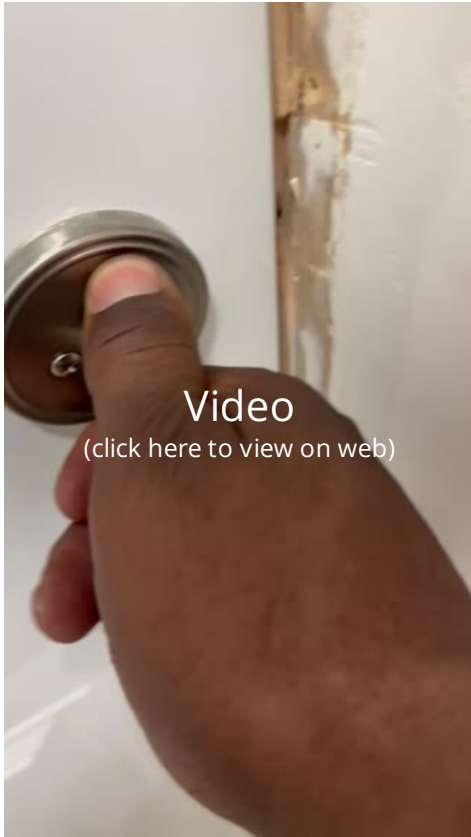
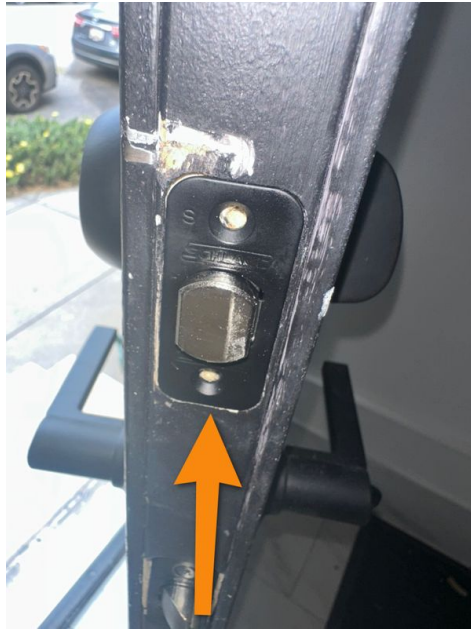
16.5.2 Windows and Door

One or more doors will not bolt locks not working when closed. Repairs should be made as necessary, and by a qualified contractor if necessary. For example, aligning strike plates with latch bolts and/or replacing locksets.

Contact a qualified handyman.

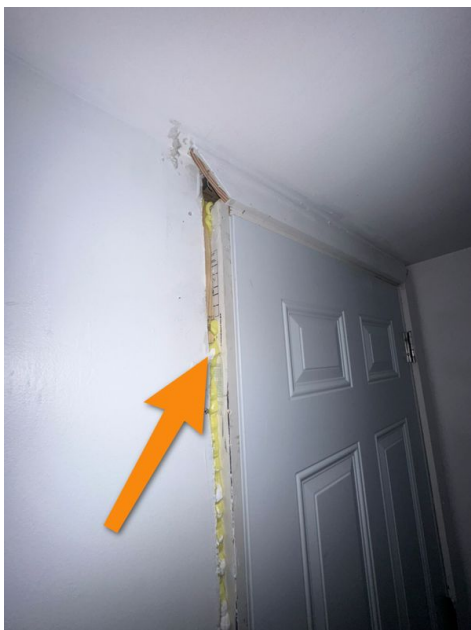
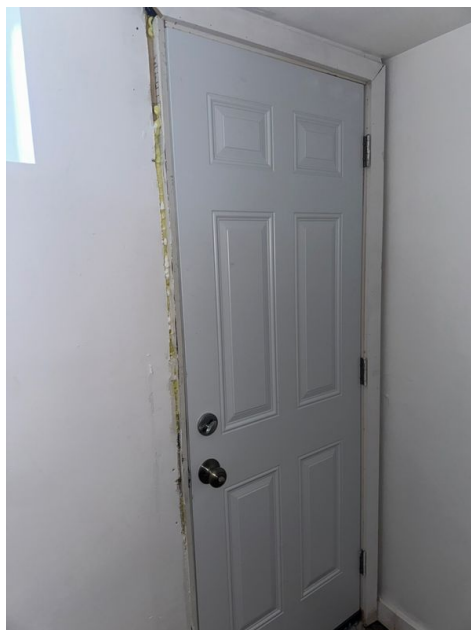
16.5.3 Windows and Door

BASEMENT DOOR NOT PLUMB

BASEMENT REAR
Recommendation

Contact a qualified door repair/installation contractor.
